## CASE STUDY 2 LONG ORCHARD

### Improving Irrigation Efficiency

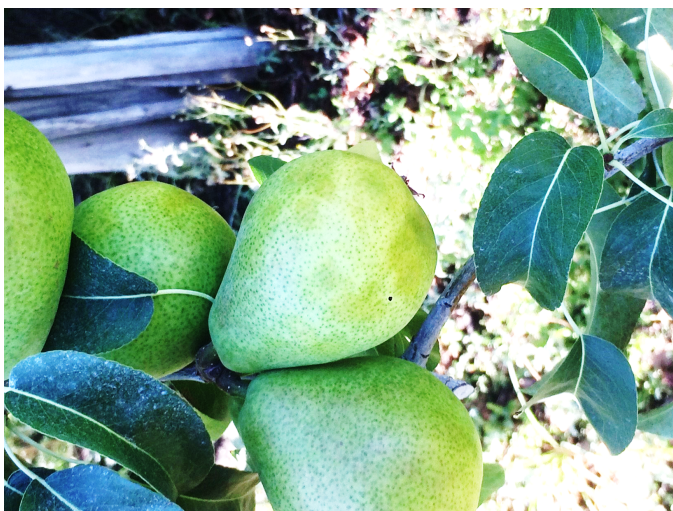
Figure 2 Cork is a challenge at this site.

- Severe cork.
- Did not pick block in 2017 due to 80% cork.

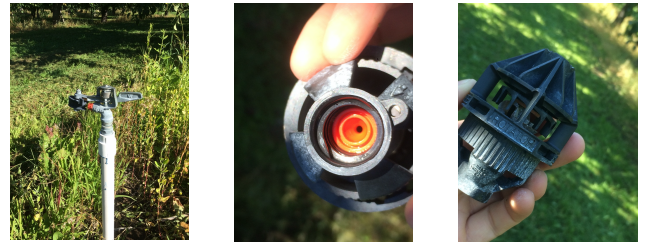
Figure 3. Rainbird sprinklers (left) and R2000 sprinklers (right).

**STANDARD SYSTEM** Impact sprinklers (Rainbird and R2000) on 24 foot by 20 foot spacing. Grower generally runs irrigation weekly during the growing season using 12 to 24 hr sets.

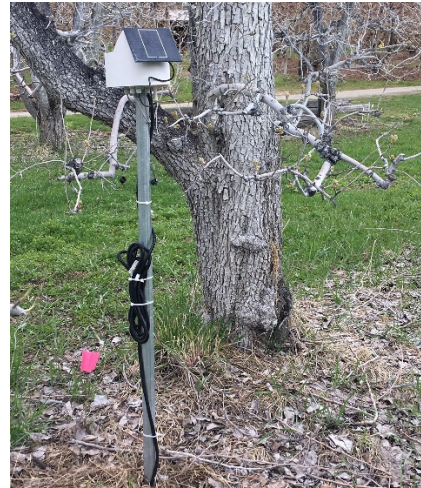
Figure 4 Sentec irrigation sensor installed April 2019.

**UPGRADE** Sentec soil moisture sensors were installed in April 2019. Irrigation in 2019 in the 'upgrade' block was done according to soil moisture needs rather than a standard schedule.

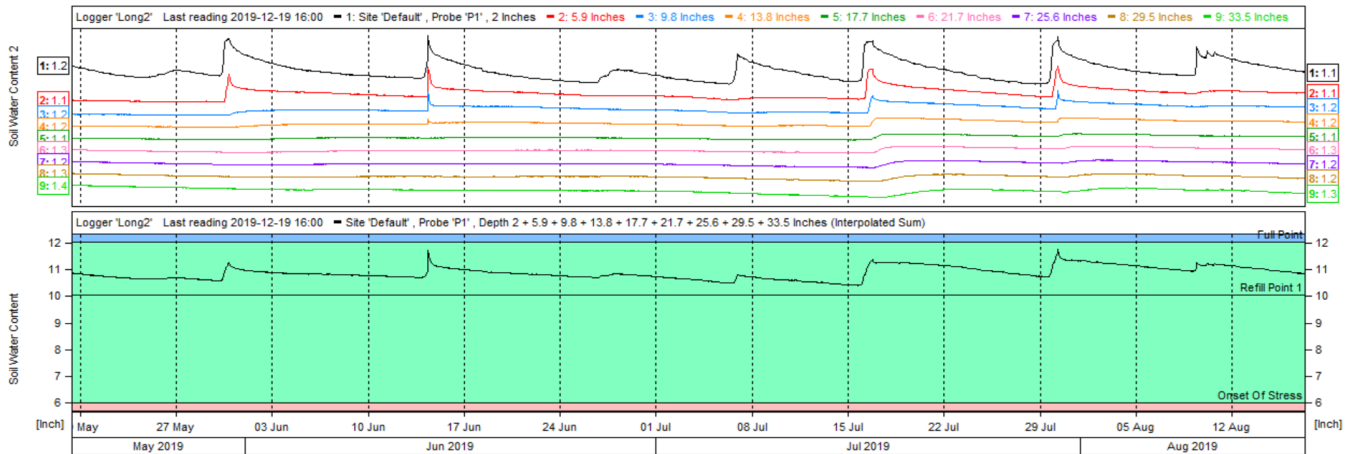
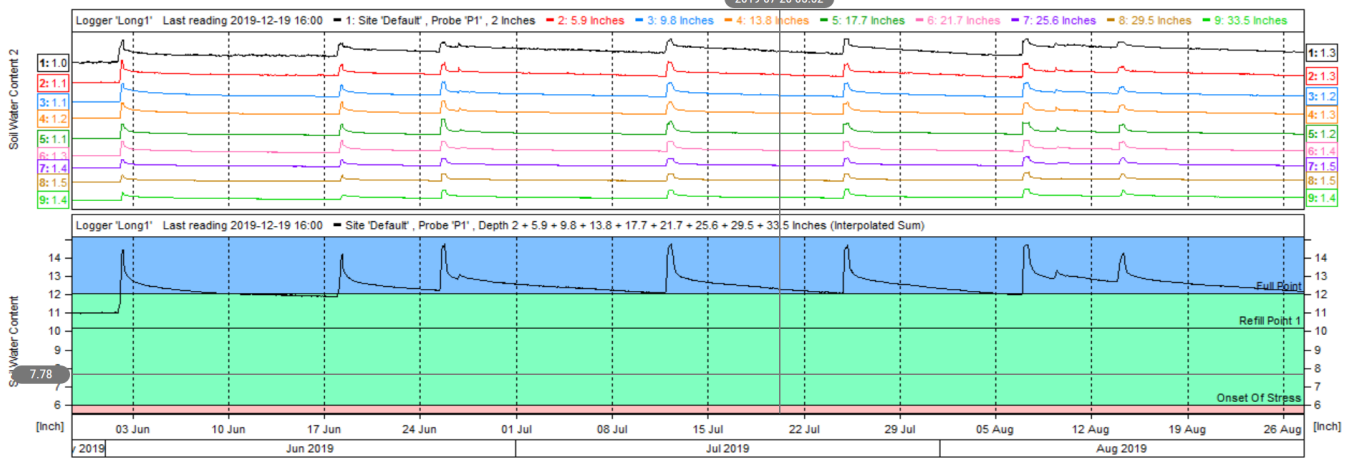
Figure 5. Soil moisture stayed above the full point (field capacity) for most of the season in the standard irrigated block compared to between refill and full in the block where Long irrigated according to soil moisture sensor readings.

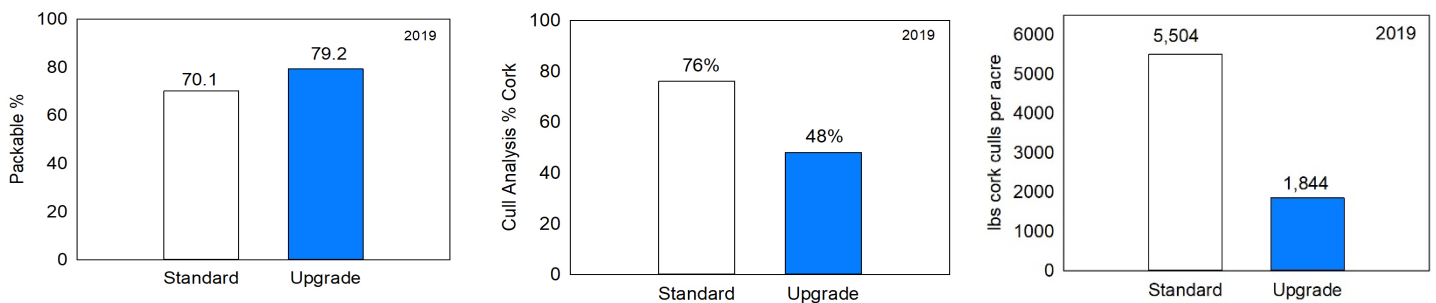
Figure 6. Fruit quality information from commercial packout from 2019 fruit packed 12/31/2019.
